Manhole Inspection Summary

Manhole # S13KK_022MH

Insp Date: **9/5/07 3:37 PM**

Location Address: **2037 DUKELAND ST**

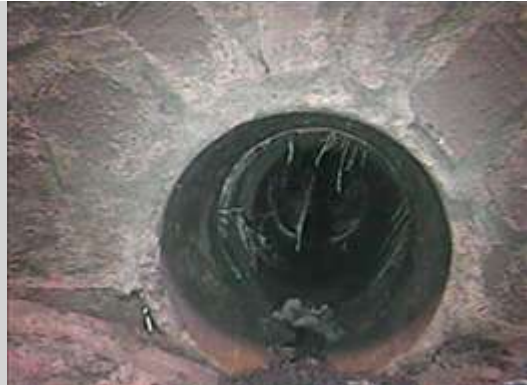
12 O'Clock Outflow

8 in. Circular Gravity Sewer
Pipe Out @ 12 O'Clock

POSSIBLE ROOT INFILTRATION DOWN
LINE
